Manhole Inspection Summary

Manhole # S47I__030MH

Insp Date: **4/23/08 10:48 AM**

Location Address: **427 s chester st** Cross Street: **unnamed alley**

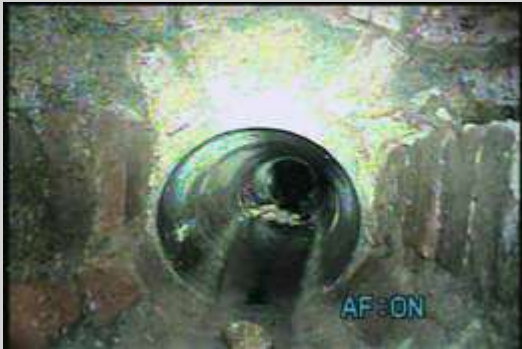
12 O'Clock Outflow

8 in. Circular Gravity Sewer
Pipe Out @ 12 O'Clock

Pipe Material: **Clay** ☐ Pipe Lined

Invert Depth: **9.33** (ft.) Flow Characteristics: **Fast**

Infiltration: **None** Pipe Seal Cond: **Unknown**

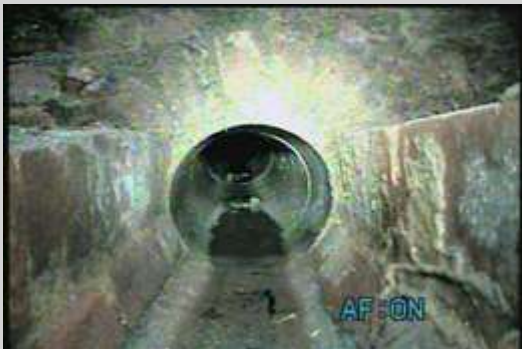
6 O'Clock Inflow

8 in. Circular Gravity Sewer
Pipe In @ 6 O'Clock

Pipe Material: **Clay** ☐ Pipe Lined

Invert Depth: **9.20** (ft.) Flow Characteristics: **Slow**

Infiltration: **None** Pipe Seal Cond: **Unknown**

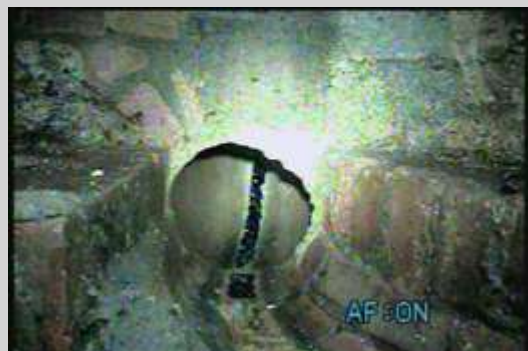
Pipe In @ 9 OClock

8 in. Circular Gravity Sewer

Pipe Material: **Clay** ☐ Pipe Lined

Infiltration: **None** Pipe Seal Cond: **Unknown**

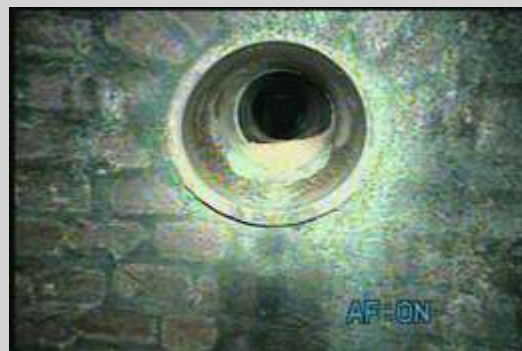
Drop In @ 9 OClock

Drop Condition: **Open**
